GOOD PRACTICES AND TECHNOLOGIES

Reducing WATER FOOTPRINT

Coating floors with polyurethane for optimization of cleaning processes in production plant

Camposol

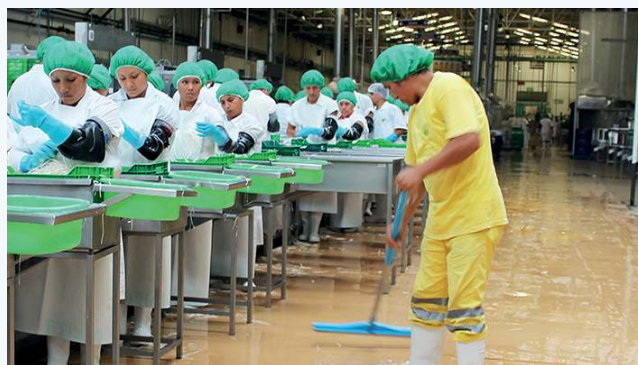
Coating floors with polyurethane covered 12,064 m² in freezing and packing processes of asparagus, artichoke, pepper and blueberries

Camposol proposed coating floors with polyurethane in selected areas. This material is smooth and facilitates the cleaning process because it needs less water to wash. This project allows savings in water resources.
